CASE STUDY

PENETRATING CRANIUM INJURY BY A CONCRETE NAIL: CASE STUDY

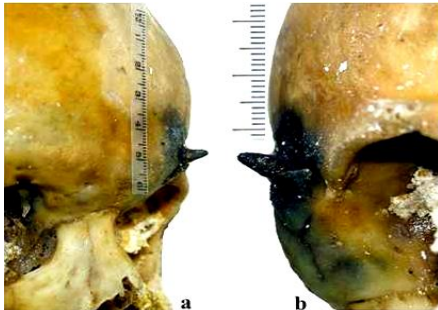
From the squama of frontal bone above the middle third of the upper edge of the left orbital socket, a conical end of the metal foreign body protruded from

the skull cavity to the outside 9 mm in length; its sharp end was oriented anteriorly, to the left and upwards (Figure 1). In the center of squama occipitalis, 26 mm from the apex of the external occipital tubercle, a perforating fracture of an oval shape measuring 16x15 mm was discovered (Figure 2). From the outer surface of the cranium, the edges of the perforating fracture are

Figure 1: A metal foreign body of a conical shape is protruding from the squama of frontal bone. Rightside view (a) and left side view (b).

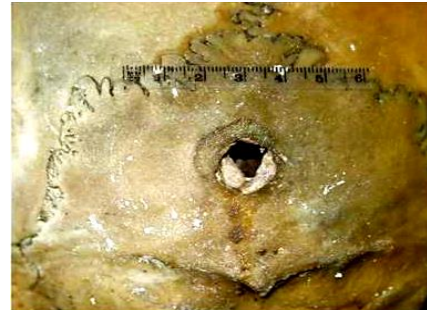
Figure 2: A perforating wound in the center of squama occipitalis.

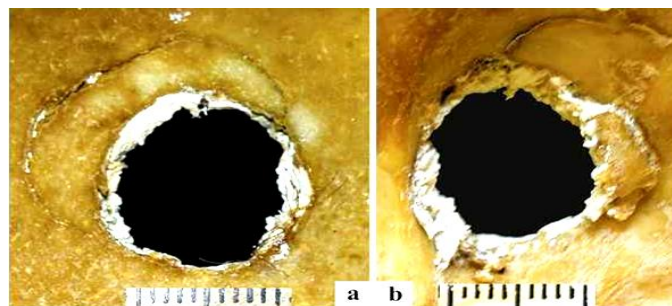
relatively even, without compact bone chipping (Figure 3a). There was an arc-shaped fissure 4-6 mm along the left half of the upper edge of the fracture. The fracture beveled from outside to inside. Inside the cranium cavity, the edges of the fracture had a prominent annular chipping, up to 3 mm wide (Figure 3b).

Figure 3: Perforating fracture in the center of squama occipitalis, outer surface view of the cranium (a) and from the inside (b).

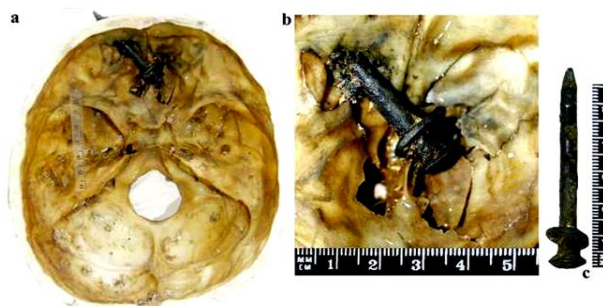
In the frontal cranial fossa, a part of a metal foreign body with corroded surface was found. It was 32 mm long, and it was stuck in the squama of frontal bone (Figure 4a). Its axis was oriented posteriorly, from bottom to top and from right to left. The inner end of the foreign body (Figure 4b) was located in the area of the “cock’s comb” and the perforated plate of the ethmoidal bone. Under this part of the foreign body a splintered fracture with a bone defect, covering the area of 38x35 mm was found. From the right edge of the defect, 4 linear fissures up to 42 mm extended to the small wing of the sphenoid bone and to the squama of the frontal bone. A foreign body was extracted from the squama of frontal bone. It was a metal concrete nail

59.4 mm long (Figure 4c). The cap was flattened, round, 10 mm in width, the gasket is flat, round, 12 mm in width. The nail’s rod was cylindrical, its cross section was round, 4.5 mm in diameter. The end of the nail’s rod was conical, with a round cross section, 2 mm in width at the tip, in its middle third - 3.5 mm. The parameters of the foreign body clearly attribute it to a fastening element - a concrete nail 4.5x60 mm in size (according to TU 14-4-1731-92⁴). After the extraction of the concrete nail, a perforated splintered fracture was revealed in the squama of frontal bone. On the cranium outer surface, it is round and limited by regular edge without compact bone chipping, with about 4, 5 mm in size (Figure 5a).

Figure 4: A metal foreign object stuck inside squama of frontal bone, discovered after cranium cavity dissection (a, b) a concrete nail 4, 5x60 mm in size (c).

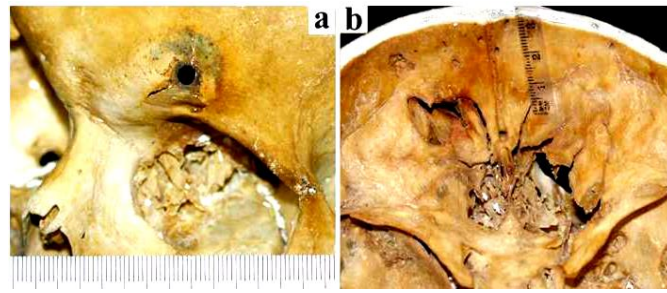
Figure 5: Perforated-fragmented fracture of squama of the frontal bone from the left side, cranium outer surface view (a) and inside the cavity (b).

From the inside, in the wall of the frontal sinus, there was a defect of an irregular polygonal shape, measuring about 15x18 mm (Figure 5b).

The described above morphological features of the perforated fracture of squama of frontal bone suggest the local fracture pattern as a result of shearing deformation caused by the contact (impact) force of a solid blunt object with a limited contact surface and having sufficient kinetic energy (speed) for penetrating action. Morphologically similar perforated fractures of the flat skull bones are verified as gunshot input bullet injuries^{1-3,5,6}.

The perforated-fragmented nature of the exit fracture is due to the anatomical structure of the squama of frontal bone of the local contact (impact) area (frontal sinus, brow arc), by an atypical nature of the projectile that initially had low travelling speed and had further reduction in kinetic energy (speed) after penetrating and passing through the first tough barrier (squama occipitalis), it is quite safe to assume, that the reduction of the projectile speed can be attributed to the structural features of the PAT from which the shot was fired, its distance and head position at the time of injury (for example, close contact with the frontal region of the head into a hard surface (concrete/brick wall, cement/wooden floor)⁶.
